Mammoth Lakes Fire Protection District
Post Office Box 5, 3150 Main Street
Mammoth Lakes, CA 93546
760-934-2300 Fax- 760-934-9210
thom@mffd.ca.gov

Title: Wood Burning Insert Issue Paper
Date: April 2, 2012
Author: Thom Heller, Fire Marshal

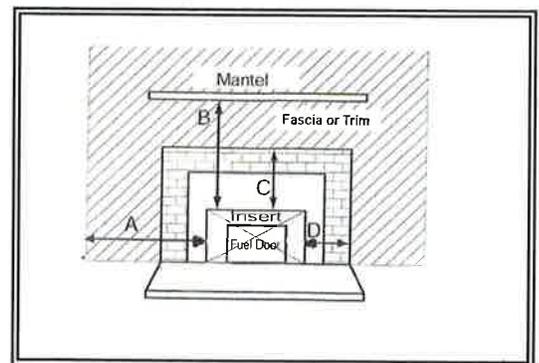
Figure 4

Figure 4- Insert instructions provide distances to combustibles as determined by insert manufacturers. Critical distances are "B" distance to mantel or similar projects of the visible wall. "C" distance to combustibles inside the wall above the insert (behind fascia material). "D" distance to combustibles inside the wall alongside the insert (lateral to the insert).

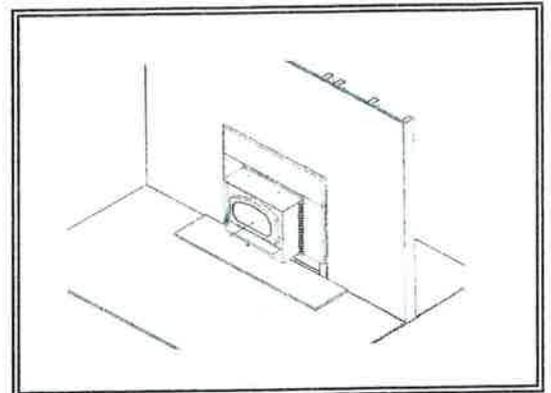
Figure 5 -With fascia in place, it is very difficult to determine the location of combustibles behind the fascia material. The first step in determining if a problem exists will be to determine if there is still a Fireplace box in place. This would involve taking the metal shrouding off from around the insert. If a Fireplace box is found then further investigation is needed. In some situations access to the construction material behind the fascia may be obtained through the exterior of the chimney chase. In most cases, getting to the appropriate location will not be possible and portions of the fascia will need to be removed to determine construction material behind.

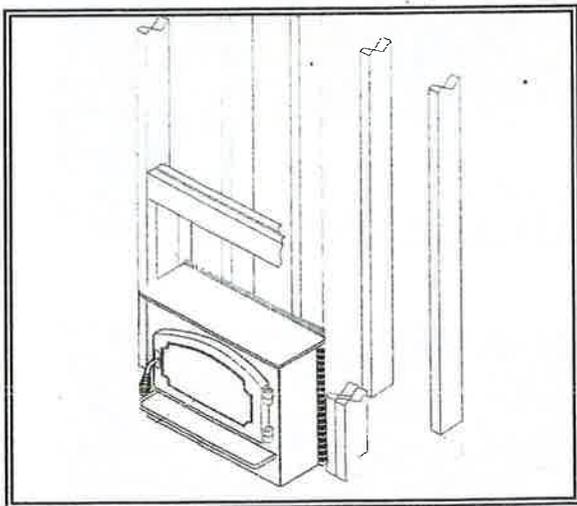
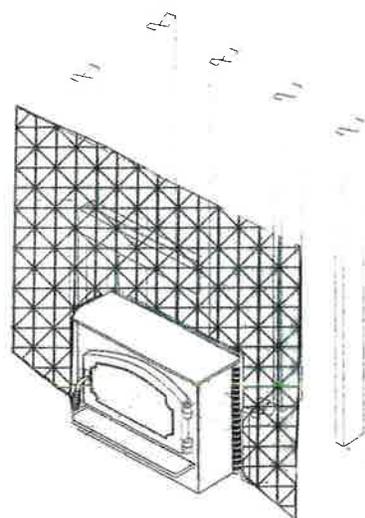
Figure 6/Figure 7- The area of concern is the immediate area around the insert. In these pictures the Fireplace box has been removed, but the area of concern is the distances to combustibles that is required for a proper installation of the insert. Distances vary with insert models, but all insert manufactures have a required distance that must be achieved to protect the combustibles from a structure fire. The shaded area in Figure 7 is the area of concern. Any combustible materials (wood, plywood, sheetrock, etc) could result in an unwanted structure fire.

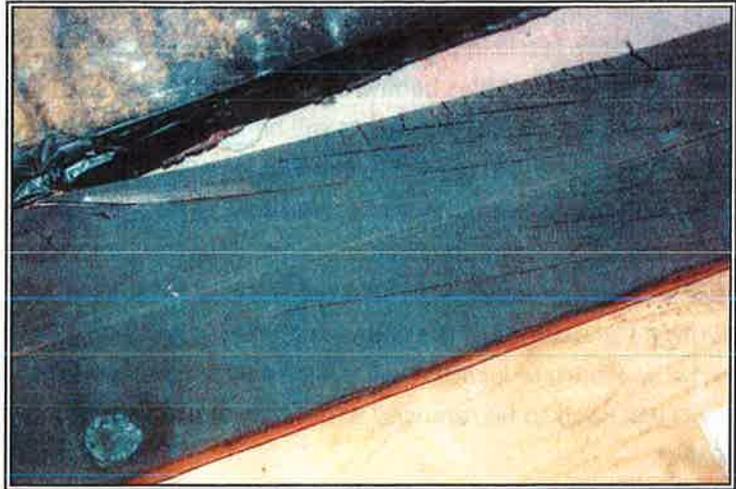
Photo 1 is pyrolysis (the slow baking of wood) that occurred to a header board in a wall of a condo unit that did not catch fire. Pyrolysis caused a charring (blackening) of the wooden material and a lowering of the ignition temperature which makes it more susceptible to ignition. This is an example of well-developed pyrolysis found in a frequently occupied condo unit.

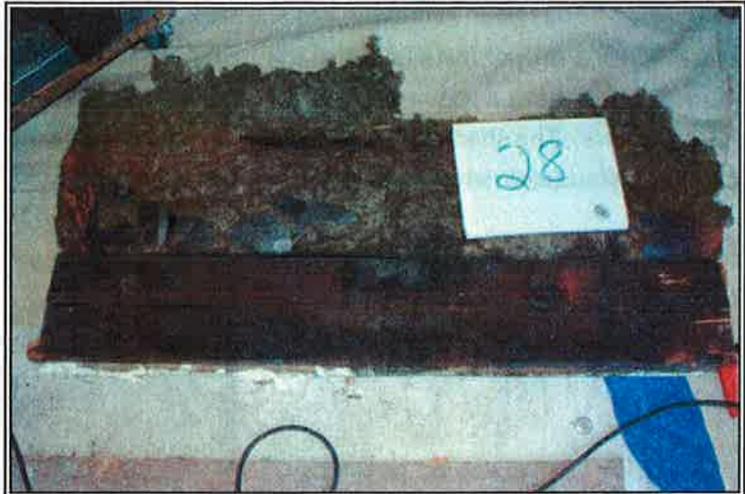
Photo 2 is pyrolysis of a 2x4 header that was removed from a condo unit that did not show signs of fire activity. Note that the paper on the insulation has completely burned away, except for a few small pieces.

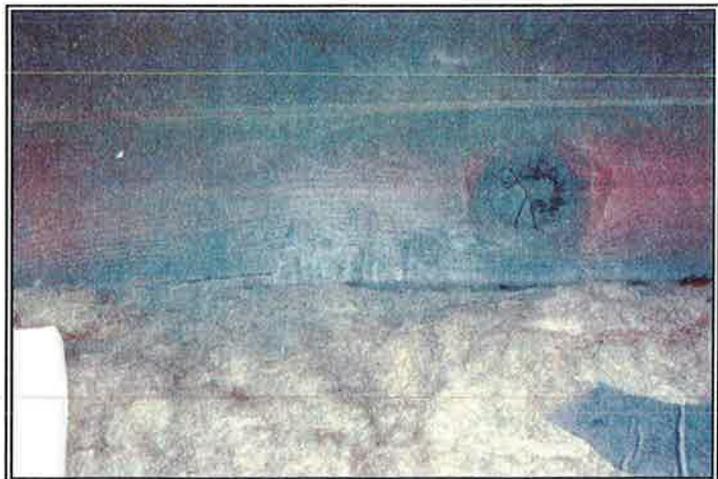
Photo 3 is advanced pyrolysis found in another condo unit. Note the alligator cracking (advanced charring). This also shows the burning away of the paper from the back of the insulation.

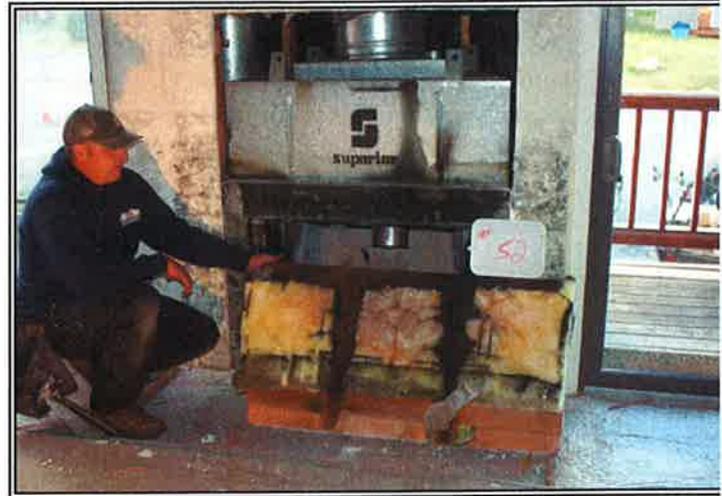
Photo 4 The picture demonstrates the seriousness of the problem. The wall section directly above the center of the insert has been removed (it is upside down). You can see the advanced charring and soot marks on the metal behind the wall section. This section is close to igniting and causing a fire.

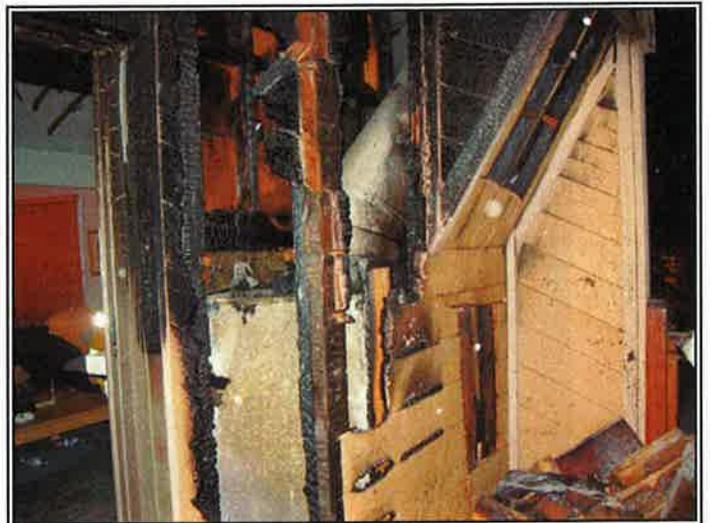
Photo 5 is an actual fire caused by pyrolysis around a wood fireplace insert. Fire occurred in March of 2010, fortunately no one was hurt.

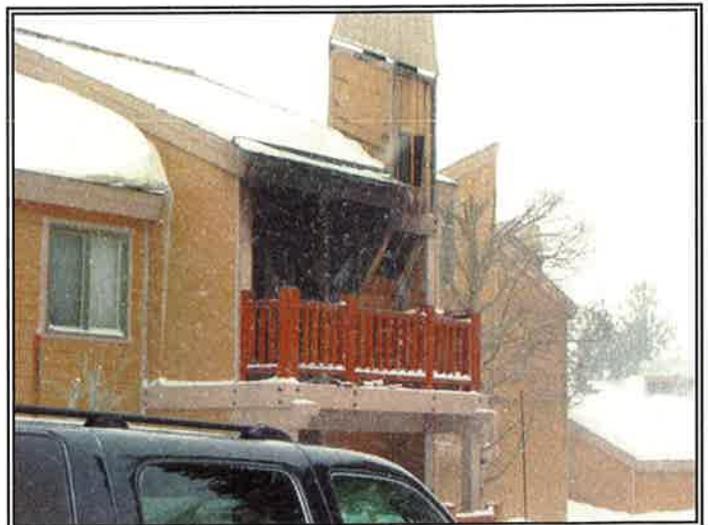
Photo 6 Same fire.

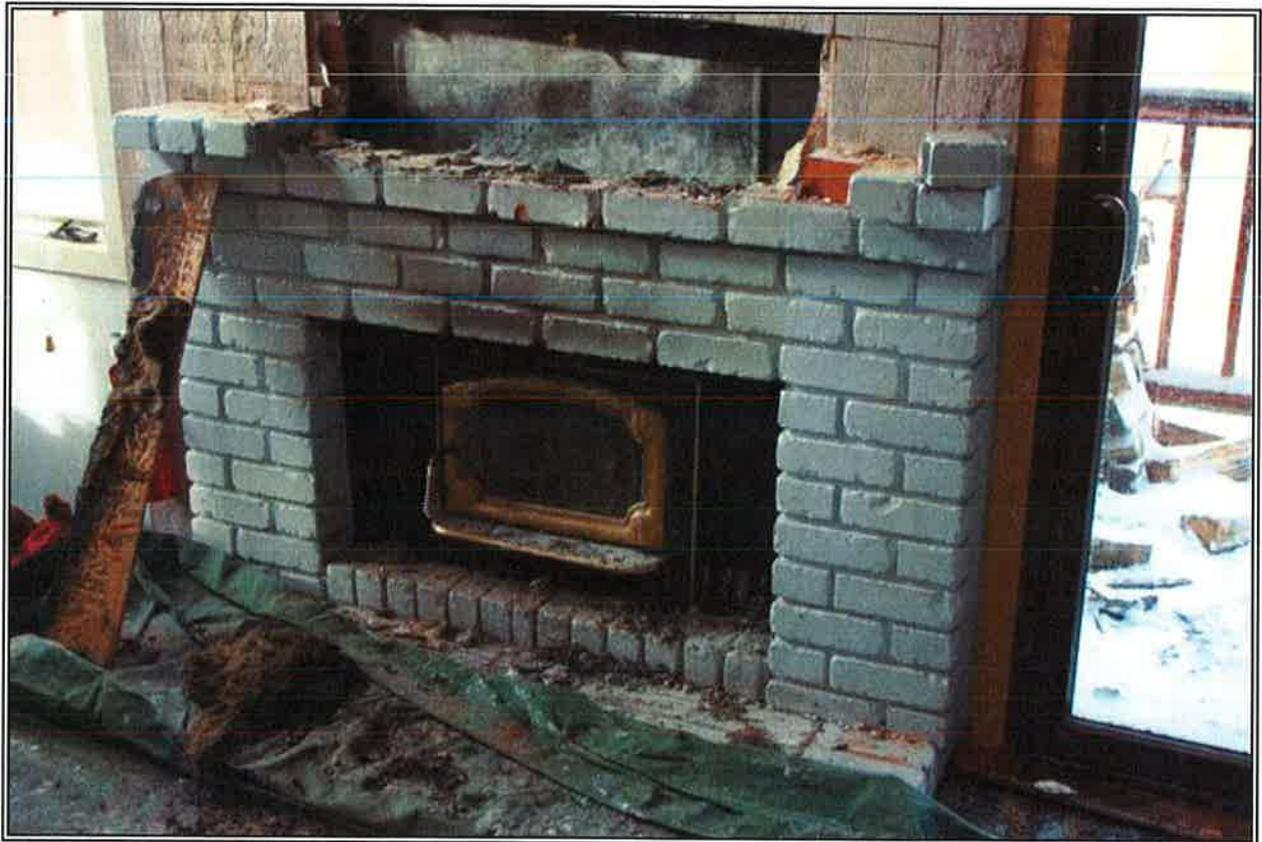
Photo 7 shows the whole problem. This is where the fire started (in the last two pictures). You can see the original “zero clearance” fireplace with the wood burning insert. The slow pyrolysis over time finally ignited in the area where the bricks are missing. The fire proceeded further into and up the chase. In many cases in order to find the damage, you need to remove the façade, in this case the bricks, and cut into the wood framing behind the façade.
