Mammoth Lakes Fire Protection District
Post Office Box 5, 3150 Main Street
Mammoth Lakes, CA 93546
760-934-2300 Fax- 760-934-9210
thom@mffd.ca.gov

Title: Wood Burning Insert Issue Paper
Date: April 2, 2012
Author: Thom Heller, Fire Marshal

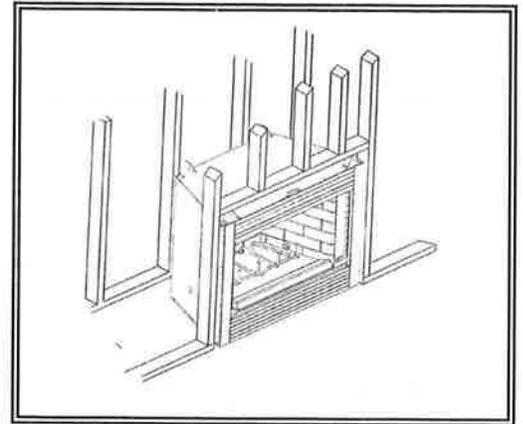
Figure 1

Figure 1- Typical Zero Clearance Fireplace (Fireplace) installation – clearances set by Fireplace Manufacturer.

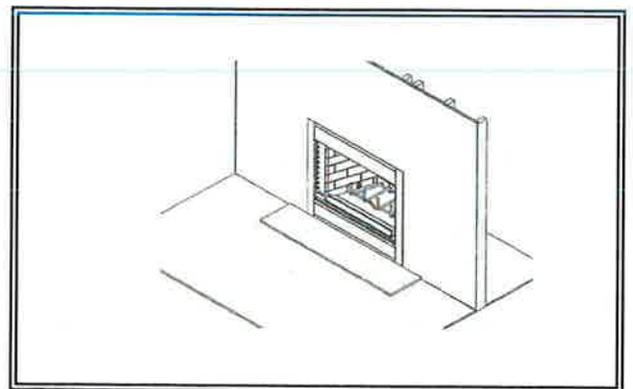
Figure 2

Figure 2-Fireplace with fascia layer added – layer usually includes non-combustible material: rock, brick, metal, or wood.

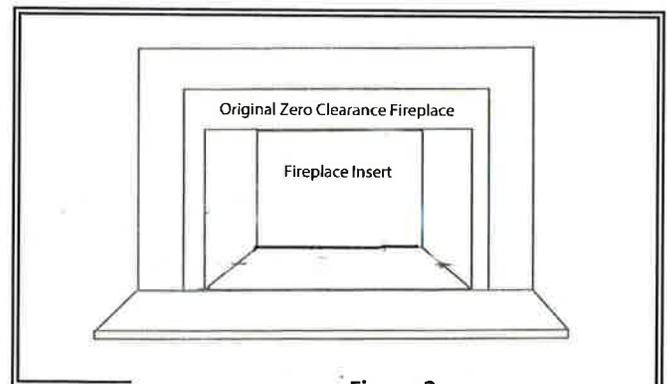
Figure 3

Figure 3-Insert fits inside Fireplace box with connections provided to existing flue piping by installer. Some insert manufacturers require lining of flue pipe with steel liner.
